Miscellaneous Paper CERC-93-2  
March 1993

*Coastal Engineering Research Program*

## **Scour Hole Problems Experienced by the Corps of Engineers; Data Presentation and Summary**

*by W. Jeff Lillycrop, Steven A. Hughes  
Coastal Engineering Research Center*

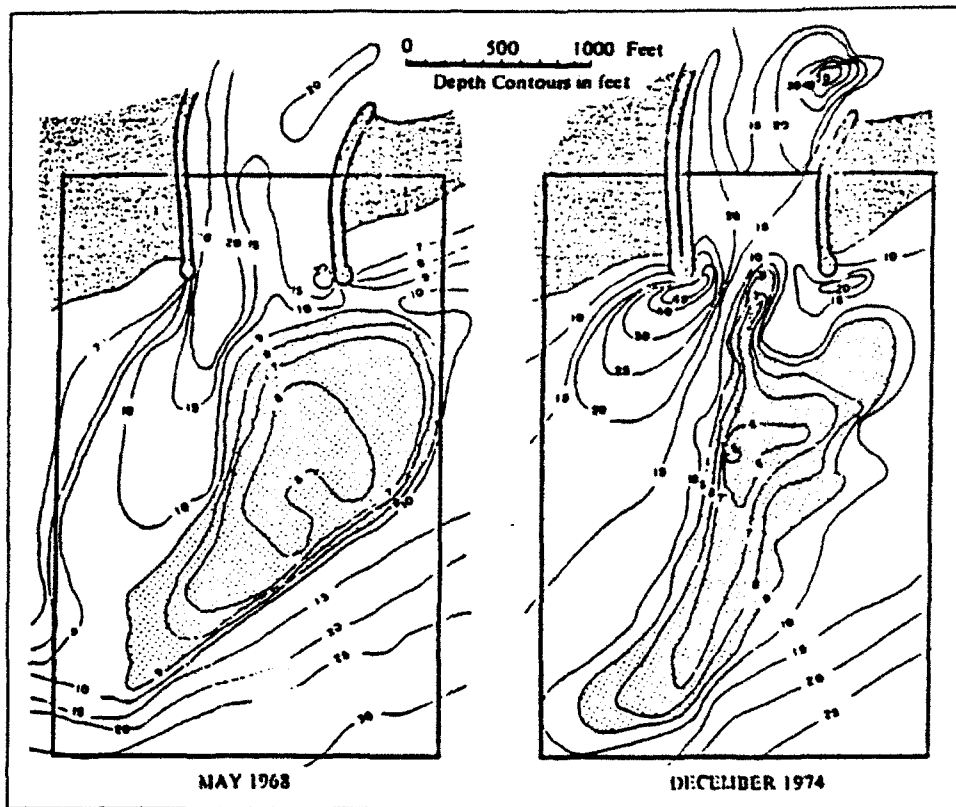
Figure 2. 1968 and 1974 bathymetry of Moriches Inlet

existence of three scour holes, one located in the back bay, and two at the jetty tips. The hole located at the east jetty is transient, appearing and disappearing as illustrated in Figure 3. Chu and Nersesian (1992) speculate this transient trend may be caused by variations in longshore transport. The net transport in the vicinity of the inlet is from east to west; thus, as transport increases, the scour hole fills; as transport decreases, the hole reforms.

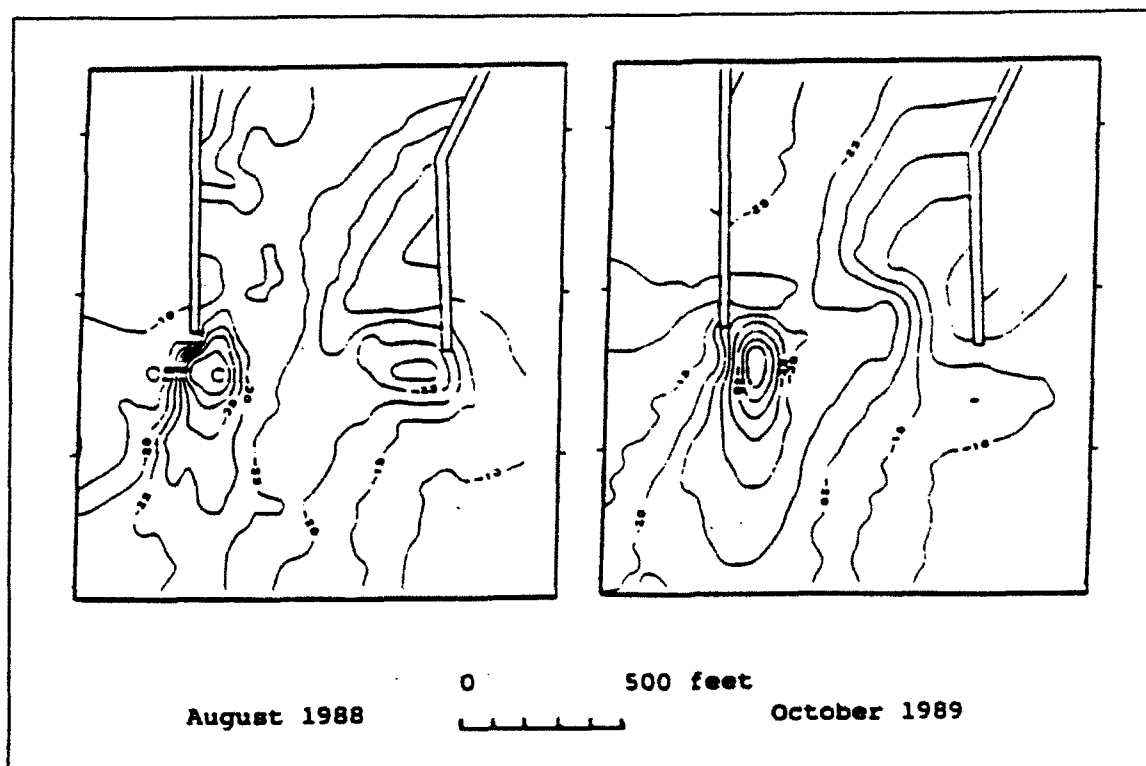
Figure 3. 1988 and 1989 bathymetry of Moriches Inlet

Between 1987 and 1989, both jetties at Moriches Inlet were refurbished at a cost of approximately \$4 million. It was found during the general design memorandum study phase that deterioration of the west jetty head was due in large part to undermining caused by the presence of the deep scour hole located just seaward of the jetty head. The scour hole is thought to be caused by swift ebb currents flowing out the east branch channel, moving diagonally across the entrance channel, and passing seaward of the west jetty tip. The intersection of the ebb jet with incoming waves creates an eddy which is thought to contribute to the scour problem.

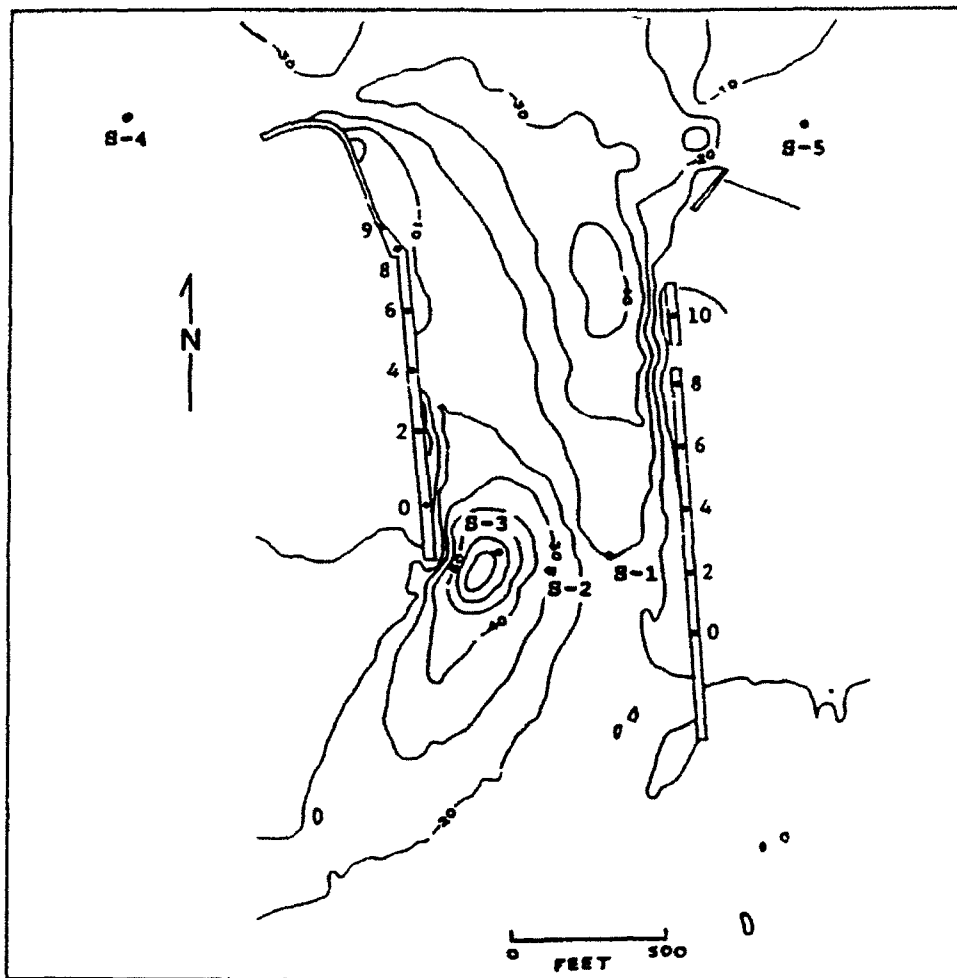
A 70-ft-deep scour hole has developed at Shinnecock Inlet adjacent to the west jetty as shown in Figure 4. This scour hole is similar to the one at Moriches Inlet; however, the problem is more severe at Shinnecock because the west jetty has been undermined and 60 - 70 ft of the jetty head has disappeared. There is also concern that the scour hole might enlarge to the point that additional toe protection material may be lost and more of the structure will be damaged.

The location and shape of the scour hole suggests that it was formed in a similar manner as hypothesized for Moriches Inlet. Strong ebb flows from the east channel are entering the inlet diagonally and flowing across the channel until they interact with either the jetty structure or the unsheltered incident wave field. In either case, it appears that large-scale rotational flows may be generated that mobilize sediment which is swept away by the current. This hypothesis is supported by the observed "scallop" shape of the hole, which is

Figure 4. Shinnecock Inlet scour hole

typical of scour caused by strong currents. There was also a diver report stating that currents created a whirlpool effect in the vicinity of the scour hole.

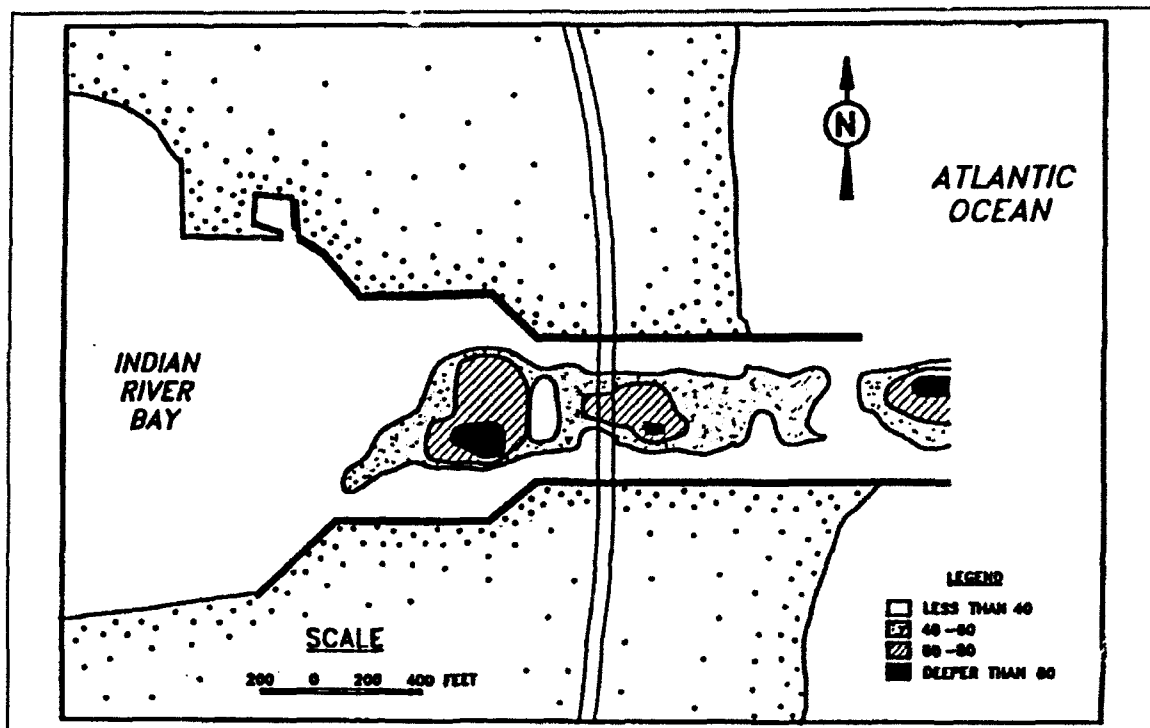
Since construction of the Federal project, the inlet has gradually increased in depth, from elevations approximately -14 ft mlw to -40 ft mlw. Figure 7

shows 1988 bathymetry conditions, and Figure 8 presents inlet cross-sectional area at different dates since construction. The increase up until the mid-1970's was gradual. In the mid-1970's the inlet cross-sectional area increase accelerated. During this same period, several large, localized scour holes formed at the tip of the north jetty and immediately on either side of the bridge piers. The scour holes at the bridge piers have depths greater than elevation -90 mlw and are continuing to deepen. The scour hole at the jetty tip has caused structural failure, and approximately 300 ft of jetty has been lost. Scour at the bridge has caused remedial action to be taken by the Delaware State Department of Transportation. In 1989 the state spent \$2.7 million to place rubble material adjacent to the bridge piers in order to halt undermining.

Figure 7. 1988 bathymetry, Indian River Inlet

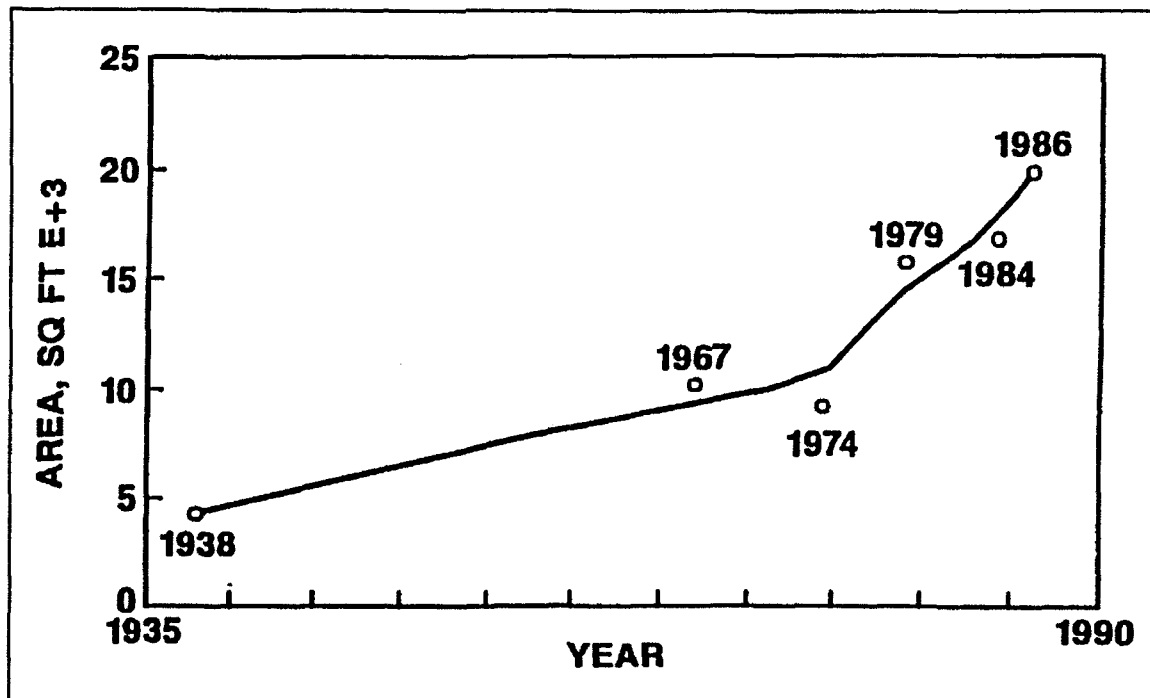
Figure 8. Inlet cross sections, Indian River Inlet

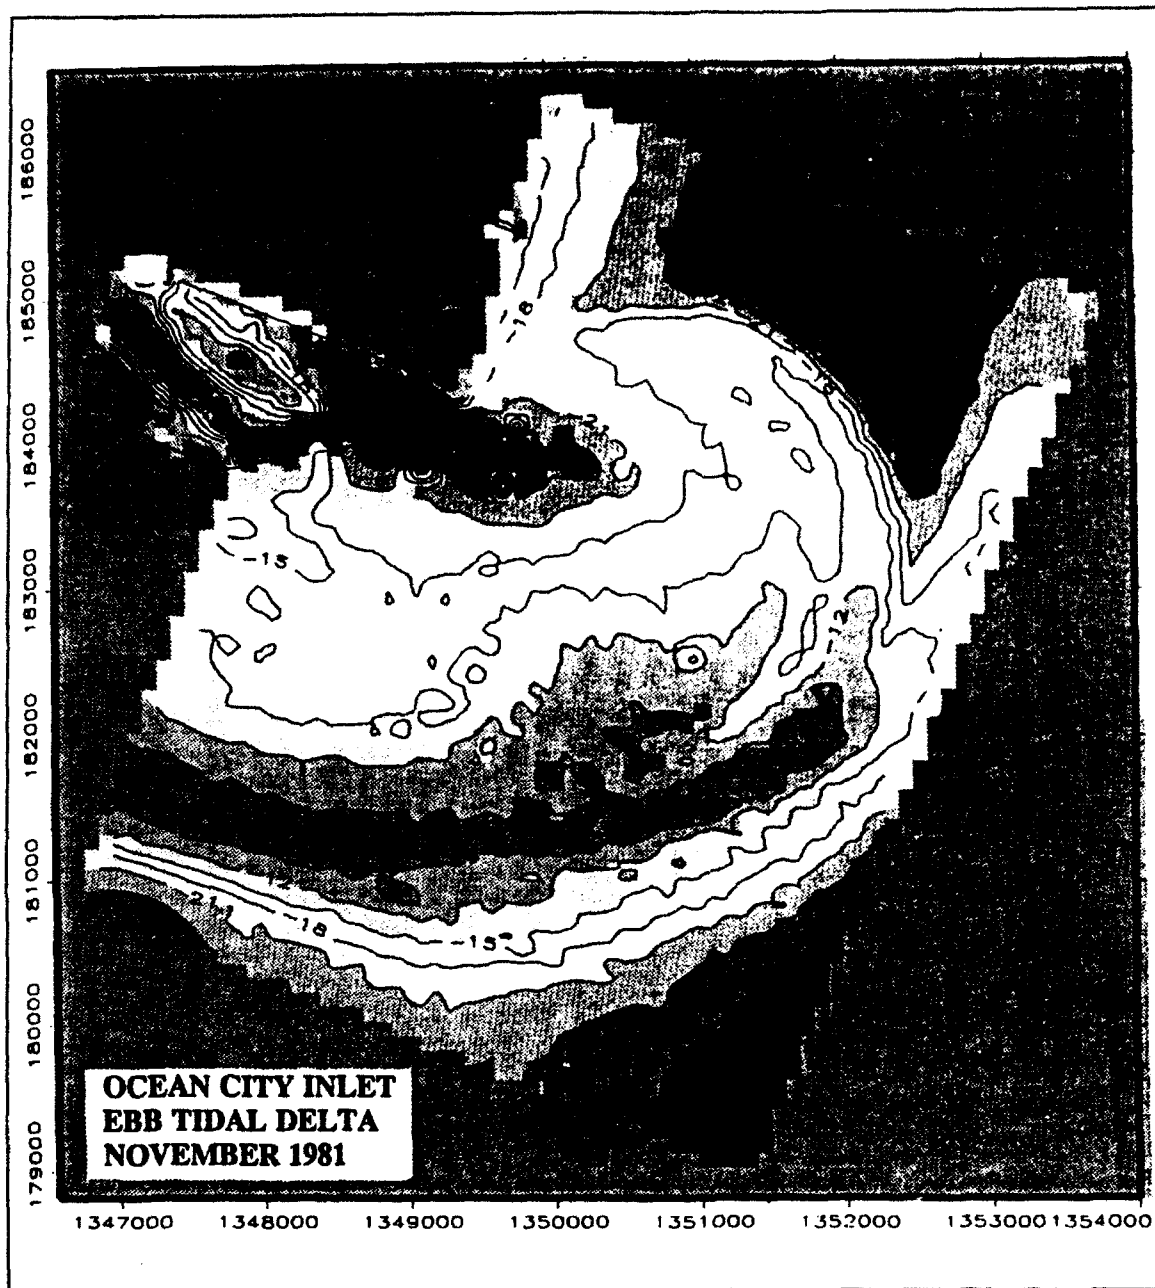
Soon after construction, the natural inlet channel migrated toward the south jetty causing scour and undermining along an 800-ft-long section of the structure. The degraded south jetty section was not immediately repaired because the inlet/jetty system remained functionally operable. A scour hole also developed near the tip of the south jetty. Figure 11 illustrates the scour at the south jetty, based on survey data taken in November 1981.

Figure 11. Scour hole at Ocean City, Maryland

In 1984 the Baltimore District filled the scour hole adjacent to the south jetty with sand hydraulically dredged from the inlet. The elevation was raised to -30 ft NGVD and capped with rubble stone weighing 50 to 200 lb. The cap was approximately 2 ft thick. In addition, an armor berm was created along this section of jetty, 2,000 ft long and 200 ft wide. Side-scan sonar was used to inspect the cap and berm in 1984 and 1990, and no subsequent erosion was found (Bass, Fulford, and Underwood, in preparation).

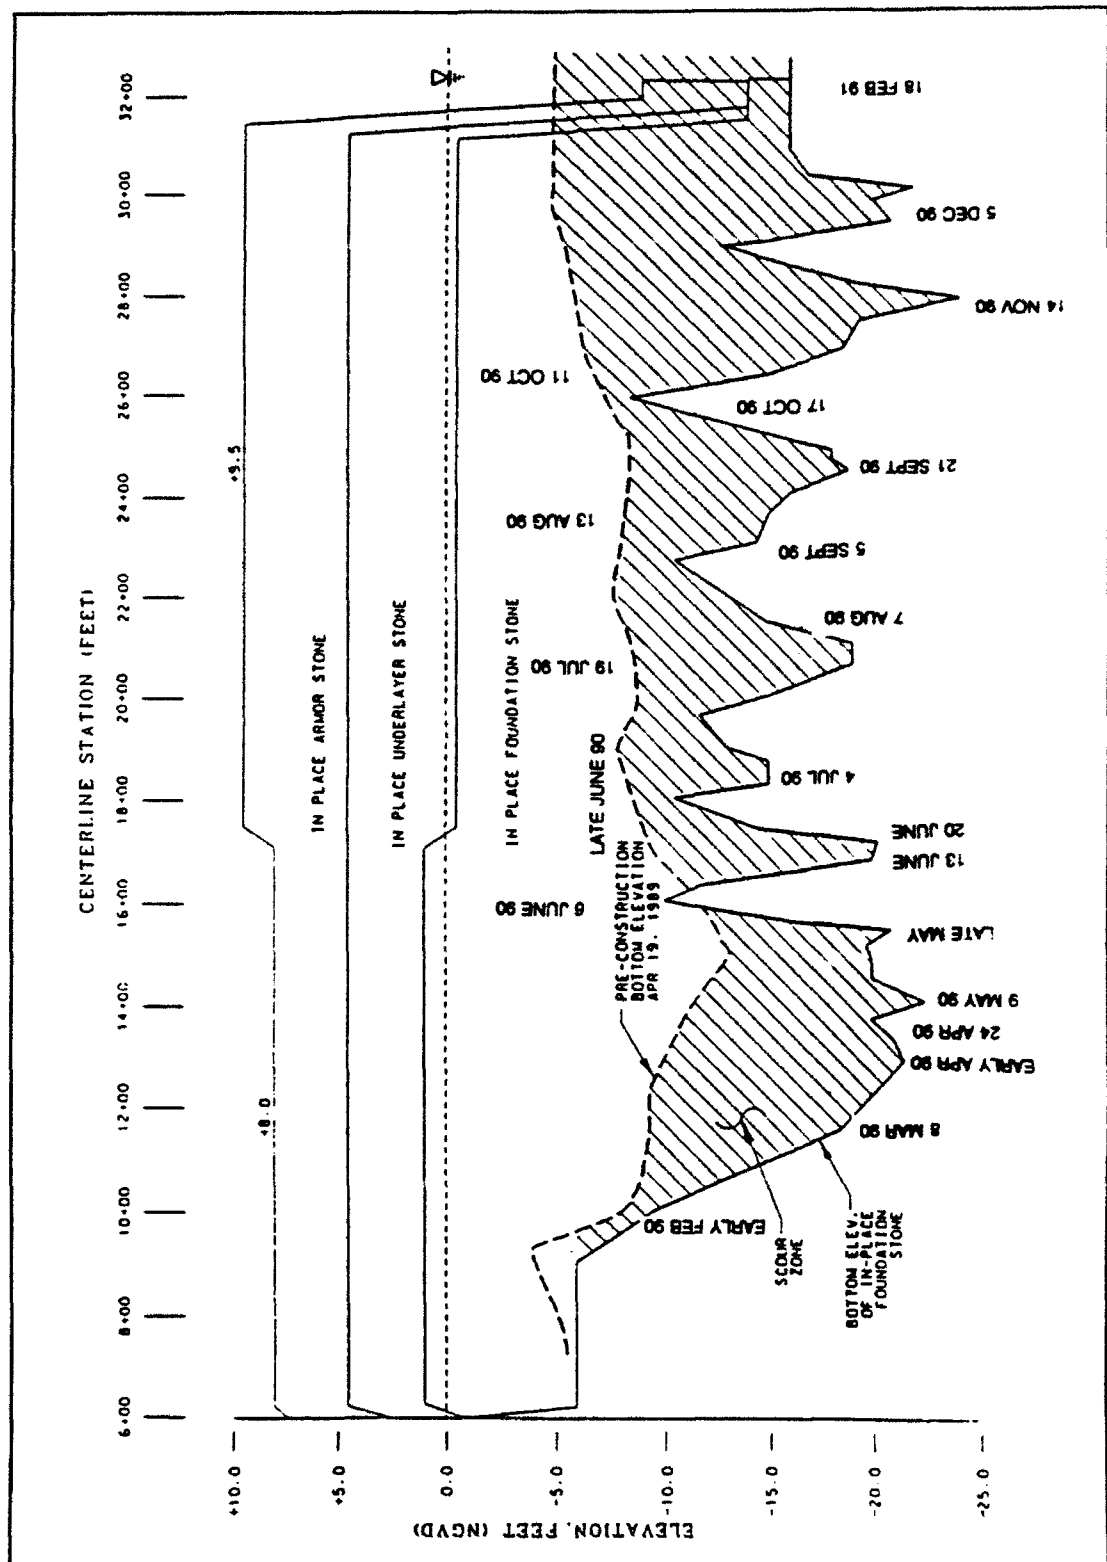
It was speculated during the May 1991 workshop that the primary cause of scour at Oregon Inlet was the ebb-flow tidal current because the deepest scour was observed on the channel side of the groin. Waves were discounted as a process contributing to the scour because most waves break on the ebb shoal, thus decreasing their effect. However, there is a possibility that nearshore currents generated by waves during storm conditions could have contributed to the scour. Aerial photographs of the groin showed currents being trained along the structure.

Figure 13. Scour during construction, Oregon Inlet, pre- and post-construction

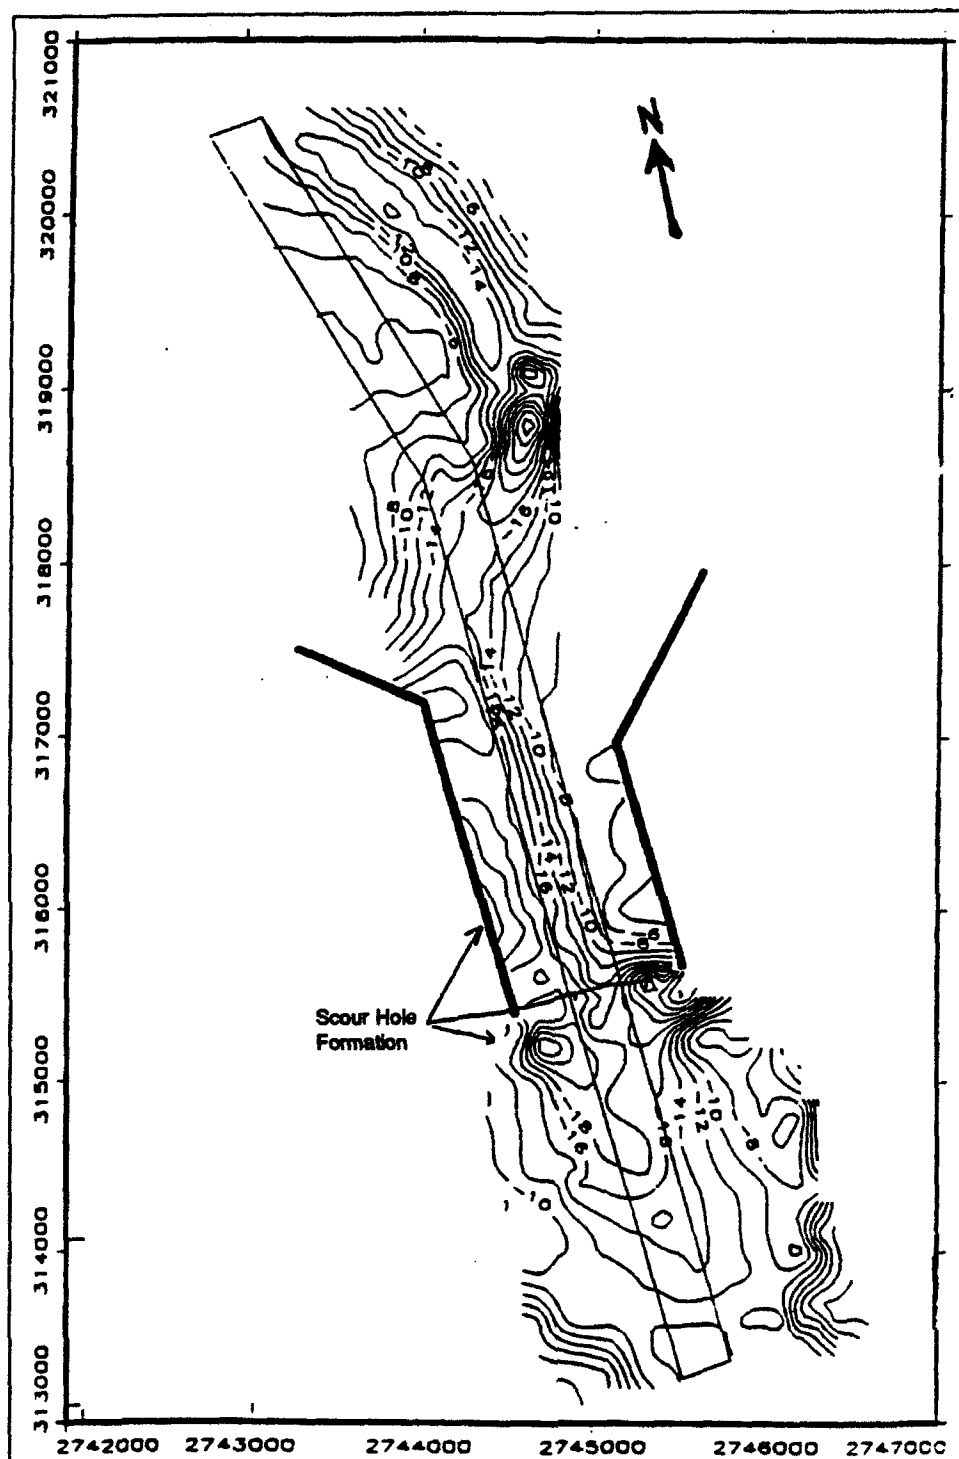
Figure 18. Scour holes at Little River Inlet

Scour at the tip of the east and west jetties appears to be caused by tidal current and structure interactions. The west jetty scour hole is approximately 10 to 15 ft deeper than the surrounding bottom. The hole at the east jetty is larger than the west jetty scour hole. The east scour hole began to form around October 1982 and had increased to a depth greater than 25 ft mlw by April 1983. In December 1983, material dredged from the inlet was used to fill the east scour hole. This filling was short-lived, however, as the deepening trend continued, and at this writing the hole was deeper than 30 ft mlw. The cause of scour at the jetty tips was suggested by Chasten and Seabergh (in preparation) to be due to tidal current and structure interaction. The deeper scour hole occurring at the east jetty is probably due to the proximity of the ebb tidal shoal, causing increased current speeds around the jetty tip.

Scour is also occurring along the west jetty adjacent to the inlet channel, and the cause appears to be different from that at the tips. Along this section, natural thalweg migration appears to be shifting the channel toward the jetty, scouring to a depth of about 20 to 25 ft mlw. Prior to construction of the navigation project, the natural channel shifted frequently; and at the time of construction of the west jetty, the natural channel was toward the southwest and Waties Island (Chasten and Seabergh, in preparation). This flow route was closed off as the west jetty was constructed and the ebb tidal flow began channelizing along the west jetty. In December 1983, dredged material from the inlet was placed in the scour hole but has since eroded away, and the hole continues to enlarge. Figure 19 shows a survey taken along the west jetty prior to dredged material placement and following placement. Note that the deepening trend continued immediately following fill placement.

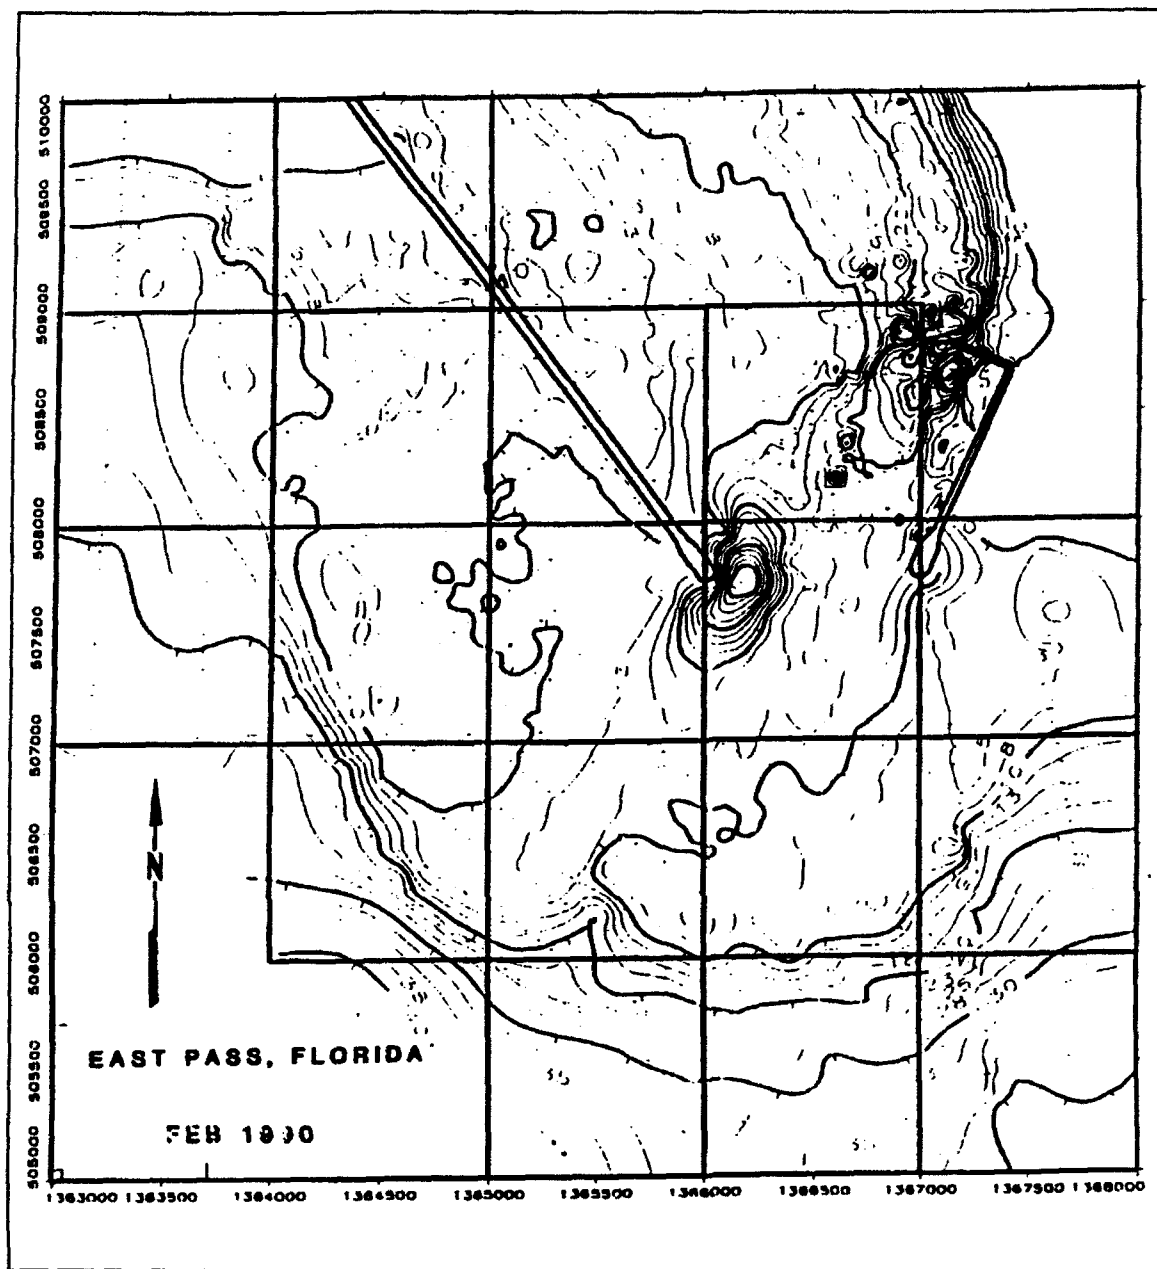
In the 1980's, a 55-ft-deep scour hole developed that ultimately resulted in the loss of the spur dike at a rate of nearly 100 ft/year. This scour hole represents scouring nearly 25 - 30 ft below the normal bottom depth in the area. Figure 28 shows a plan view of the location of the scour hole at the spur groin and another scour hole at the tip of the west jetty.

Figure 28. East Pass scour holes (Morang 1992)

To minimize adverse scour, the report recommends the following (Morang 1992):

- a. The spur groin can be rebuilt with extensive toe protection to prevent collapse. The scour hole near the tip of the spur would have to be filled and then armored to prevent future scour. While the use of concrete and rubble fill in the past provided only temporary relief, an engineered approach employing precisely placed armor units might be more successful.
- b. The scour hole at the tip of the west jetty should also be filled and capped with armor stone to prevent damage to the jetty.

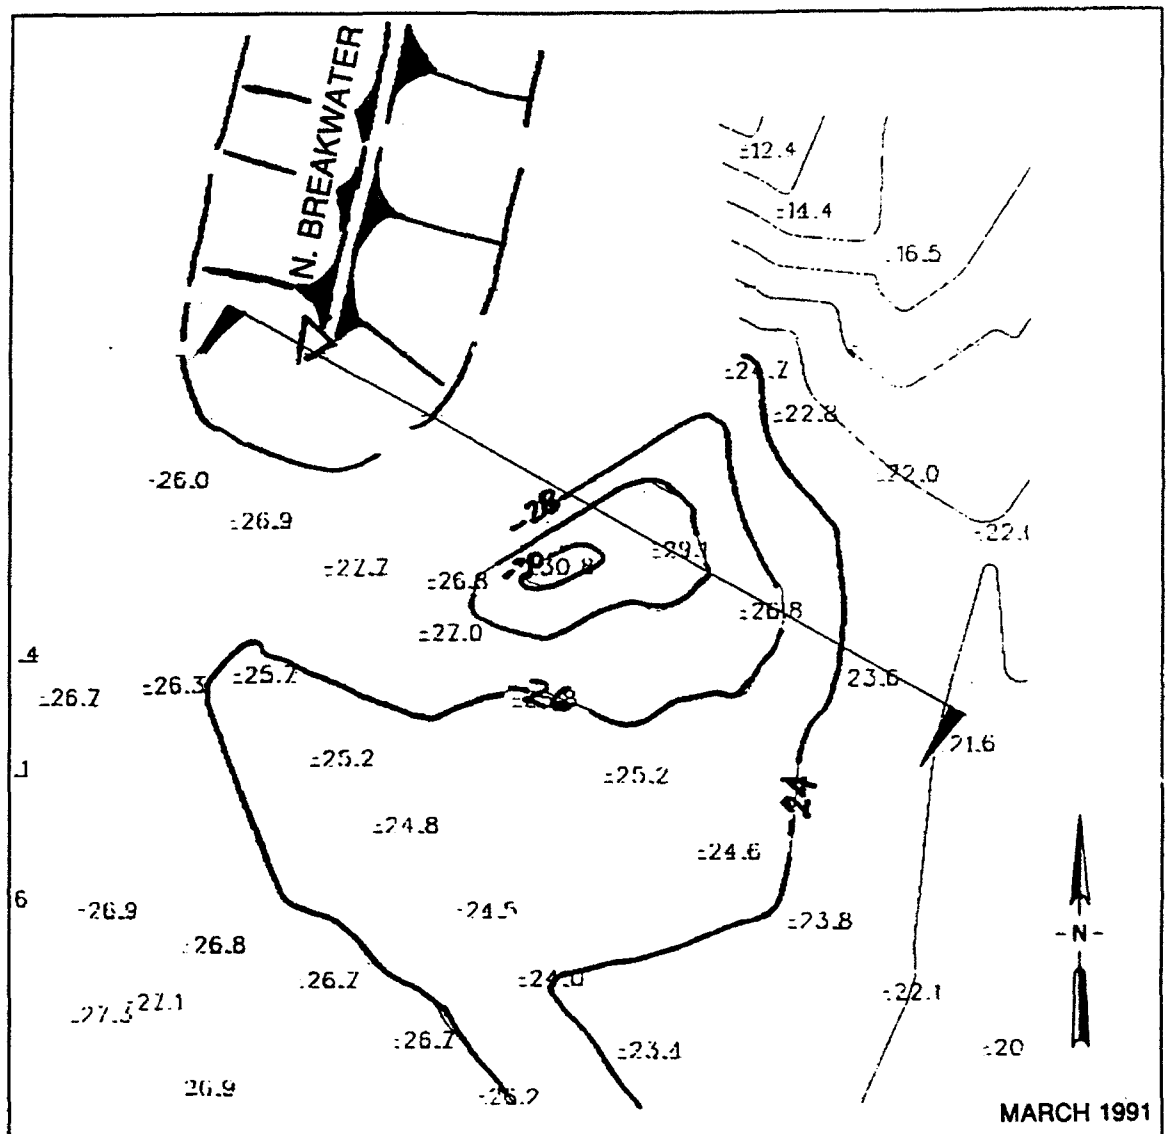
Figure 30. Morro Bay scour hole, plan view

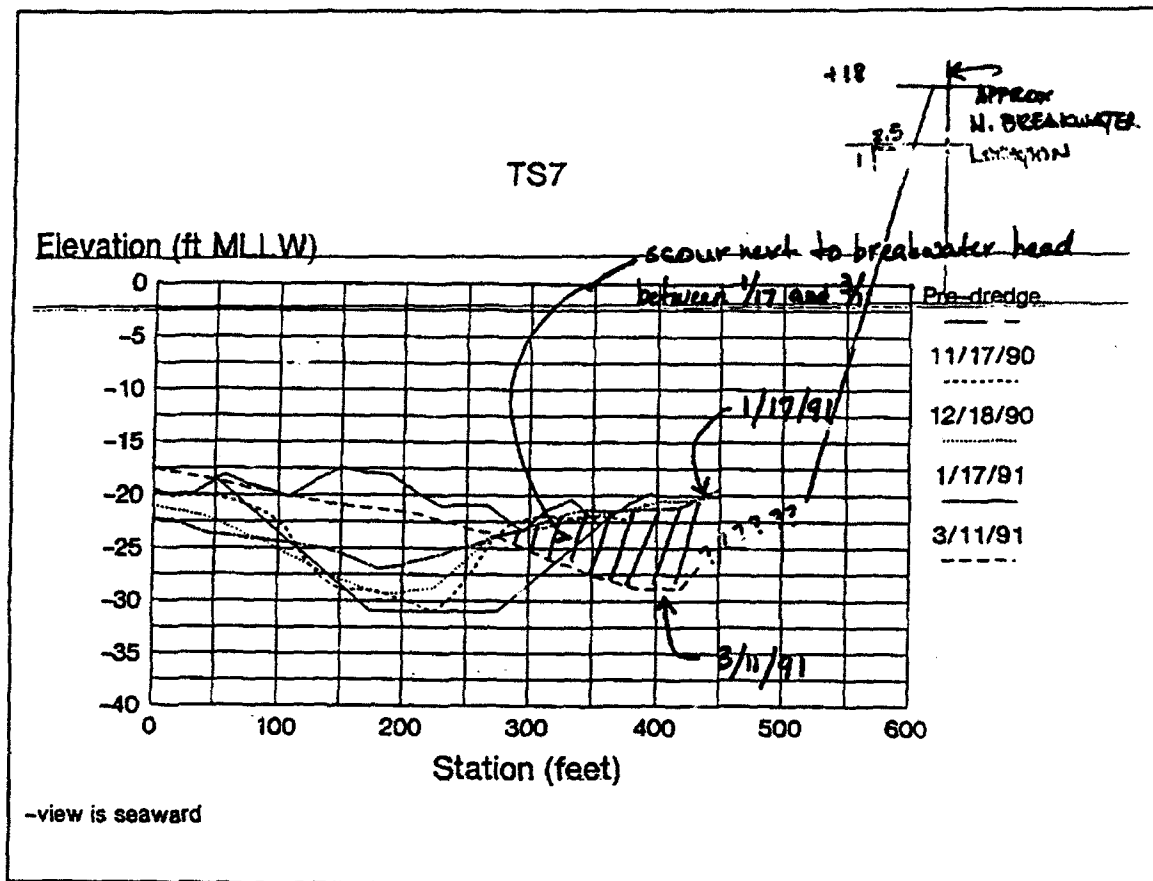
Figure 31. Morro Bay scour hole cross section

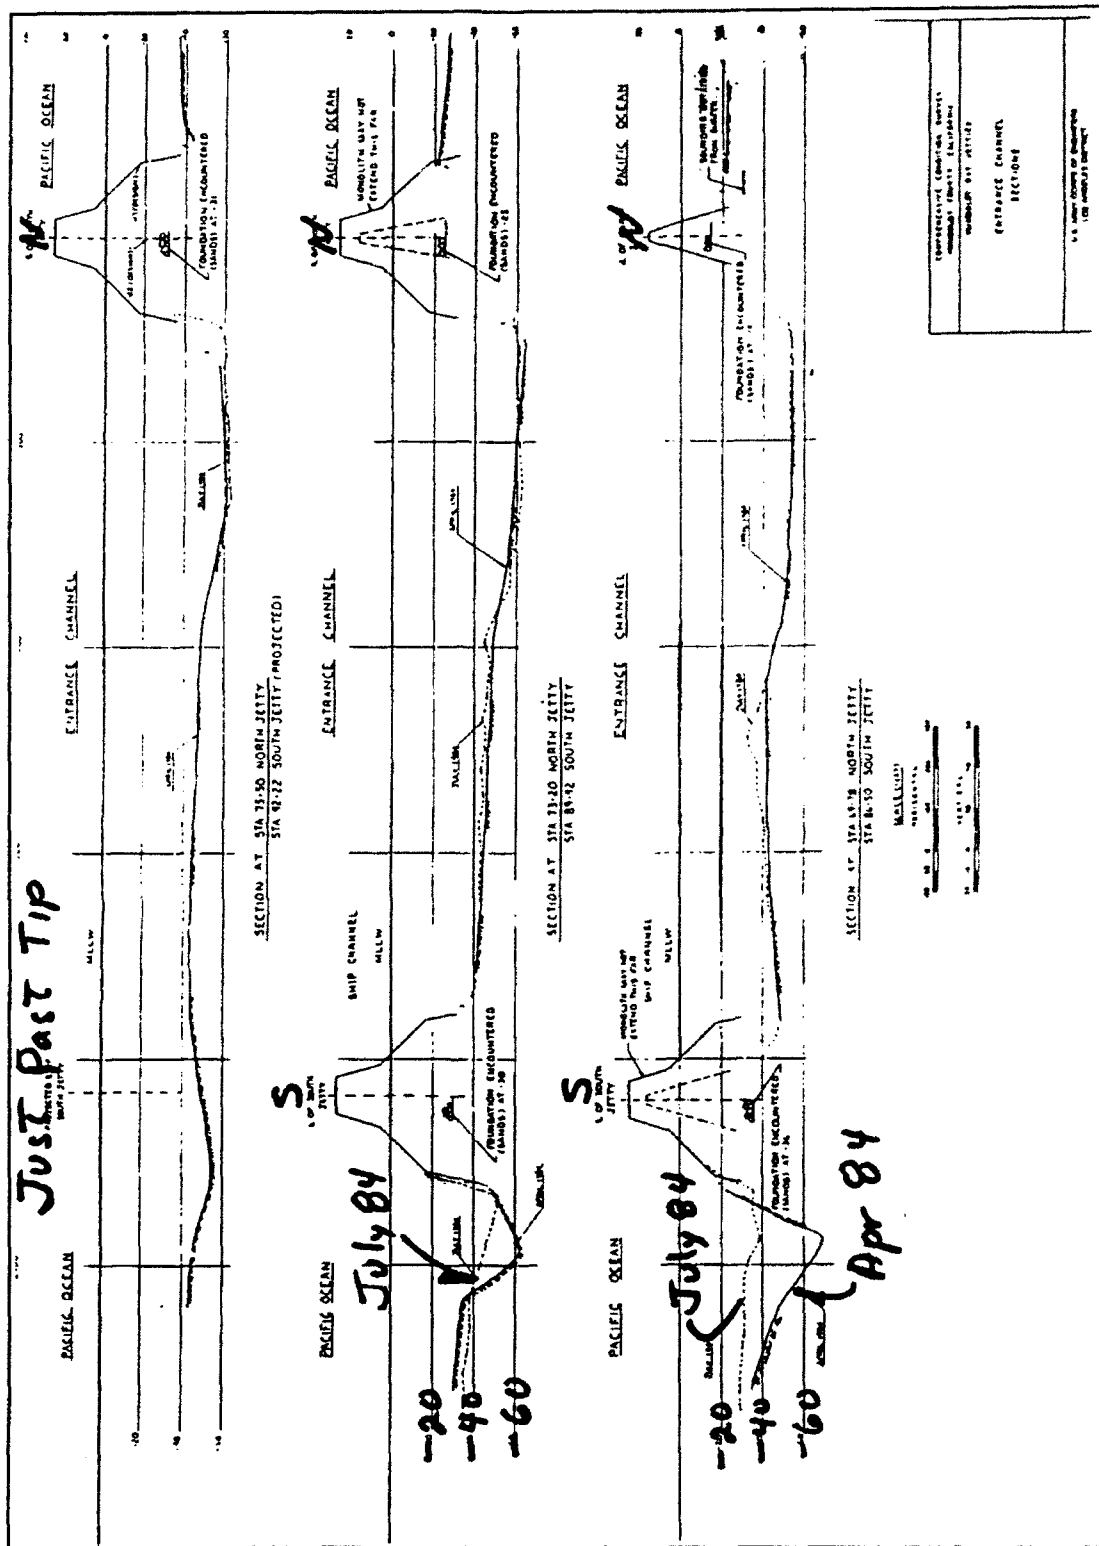
Figure 33. Humboldt Bay south jetty rip channel scour

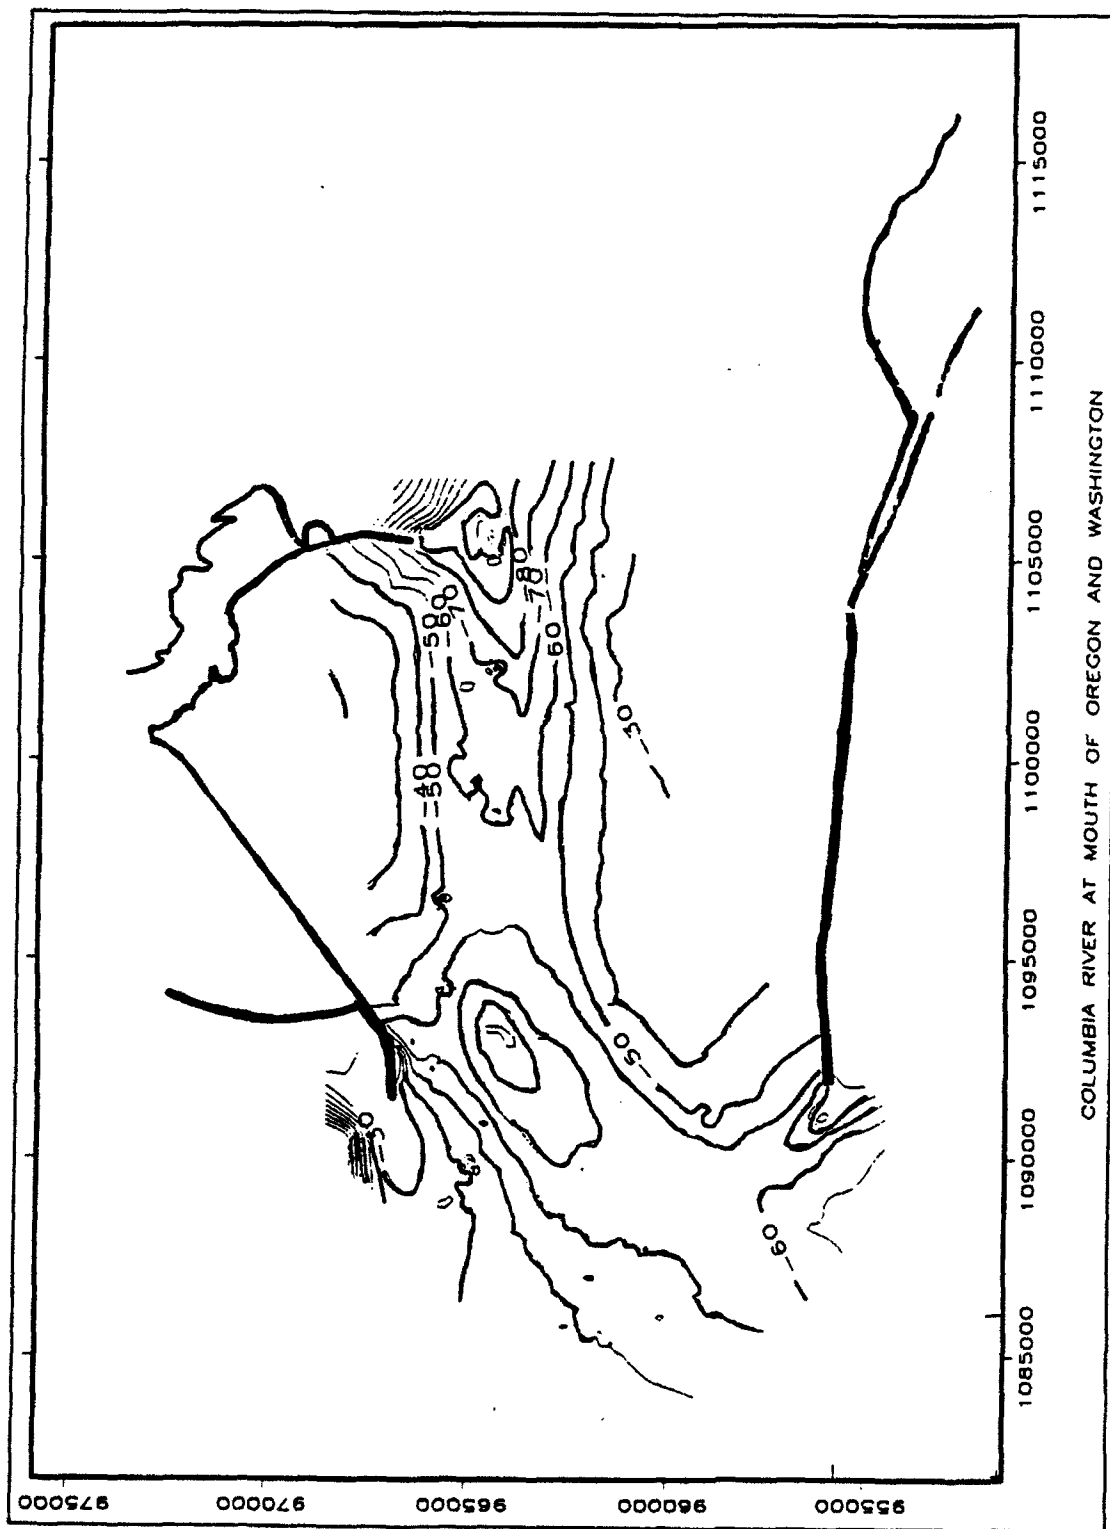
A large scour hole is located just south of the submerged end of the north jetty (Figure 39). This hole tends to scour to depths on the order of 80 ft

Figure 39. Columbia entrance bathymetry

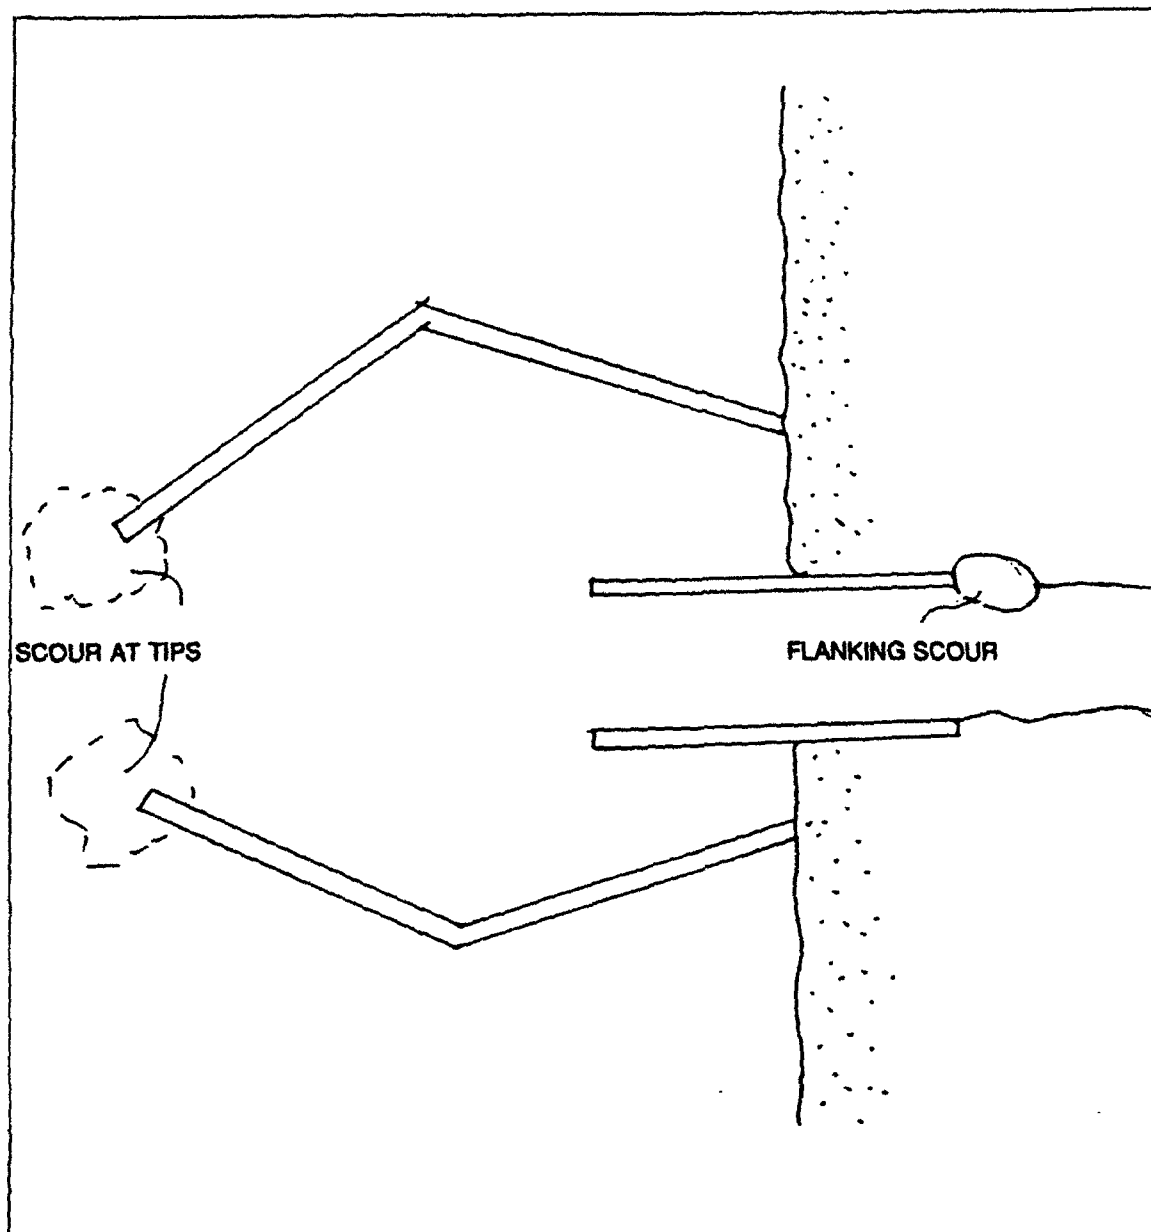
Figure 44. Scour problems at Lake Michigan harbors
